INSPECTION REPORT

Nevada Division of Environmental Protection Bureau of Water Pollution Control

FACILITY TITLE: WABUSKA POWER PLANT

FACILITY DESCRIPTION: GEOTHERMAL POWER PLANT

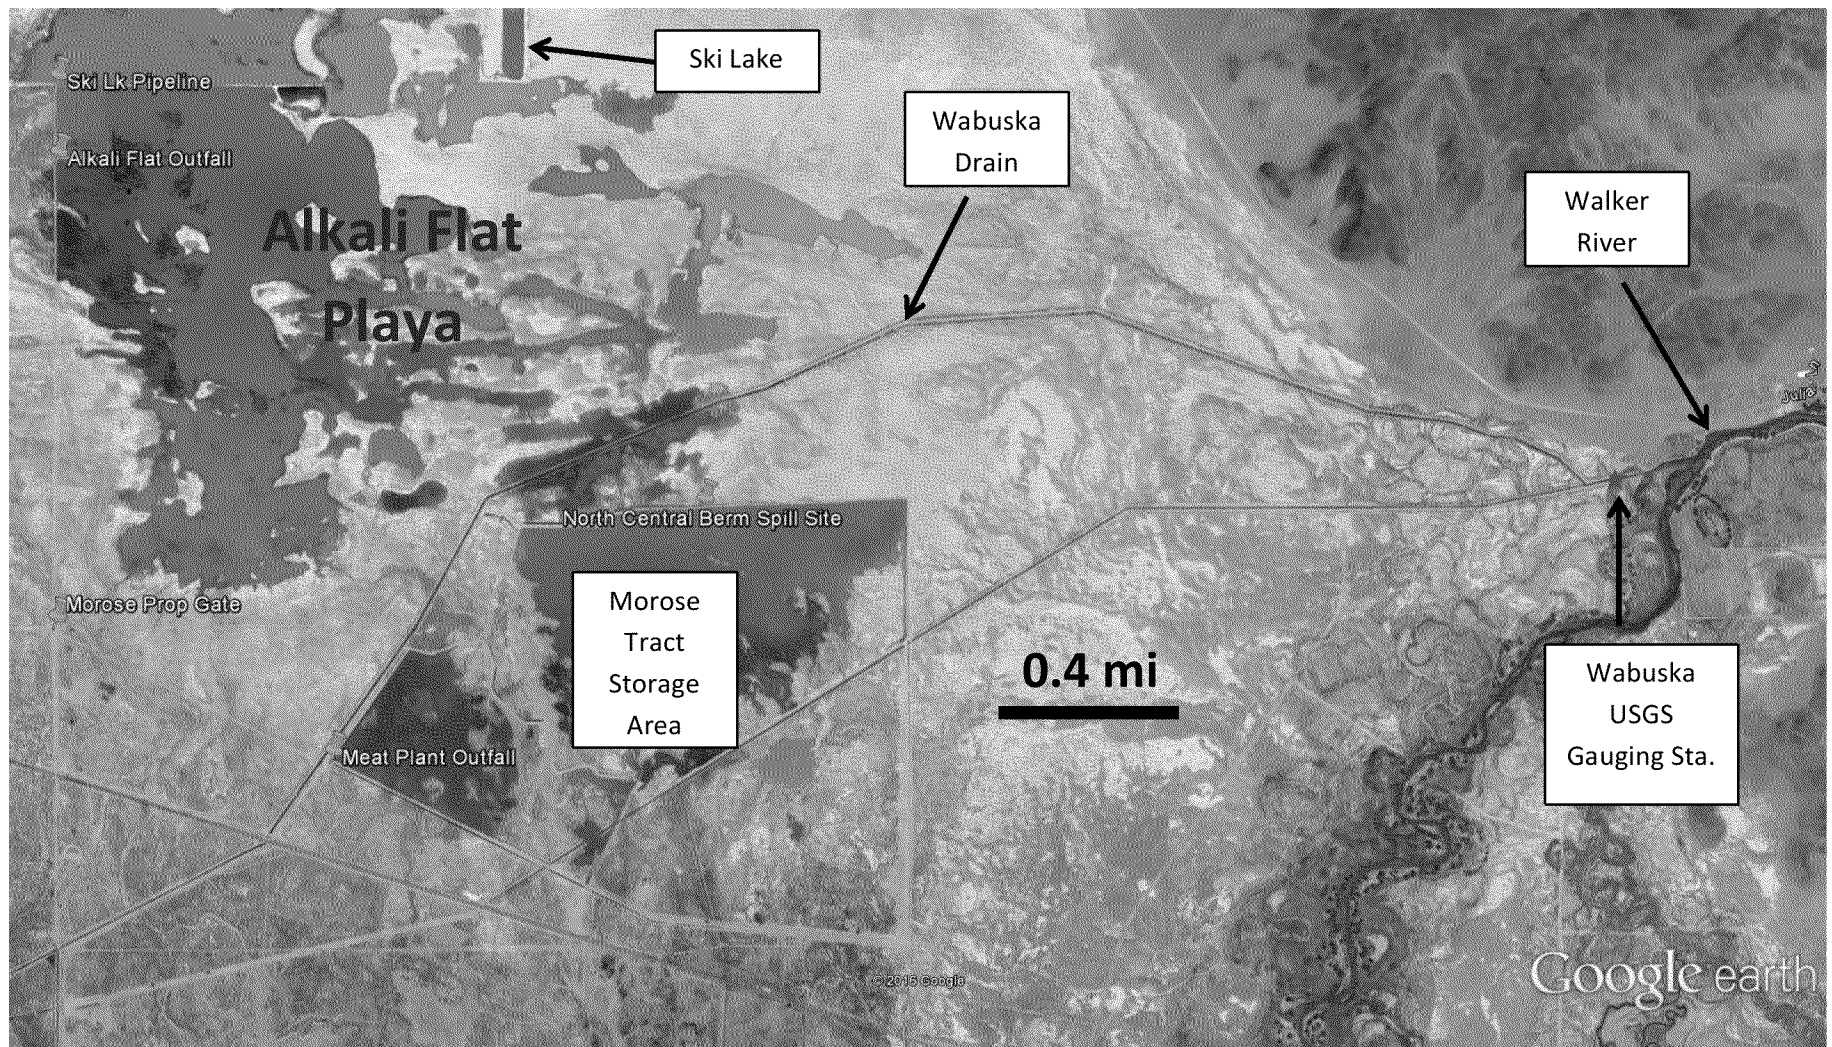
Figure 3: Location of the area of Spill Report 160314-02 and the area described in the “Five Day Report” submitted by Homestretch Geothermal. The Wabuska Drain and Walker River are shown. Permitted outfalls are also shown (Ski Lake, Alkali Flat, and Meat Plant). Imagery date is 6/13/2015.

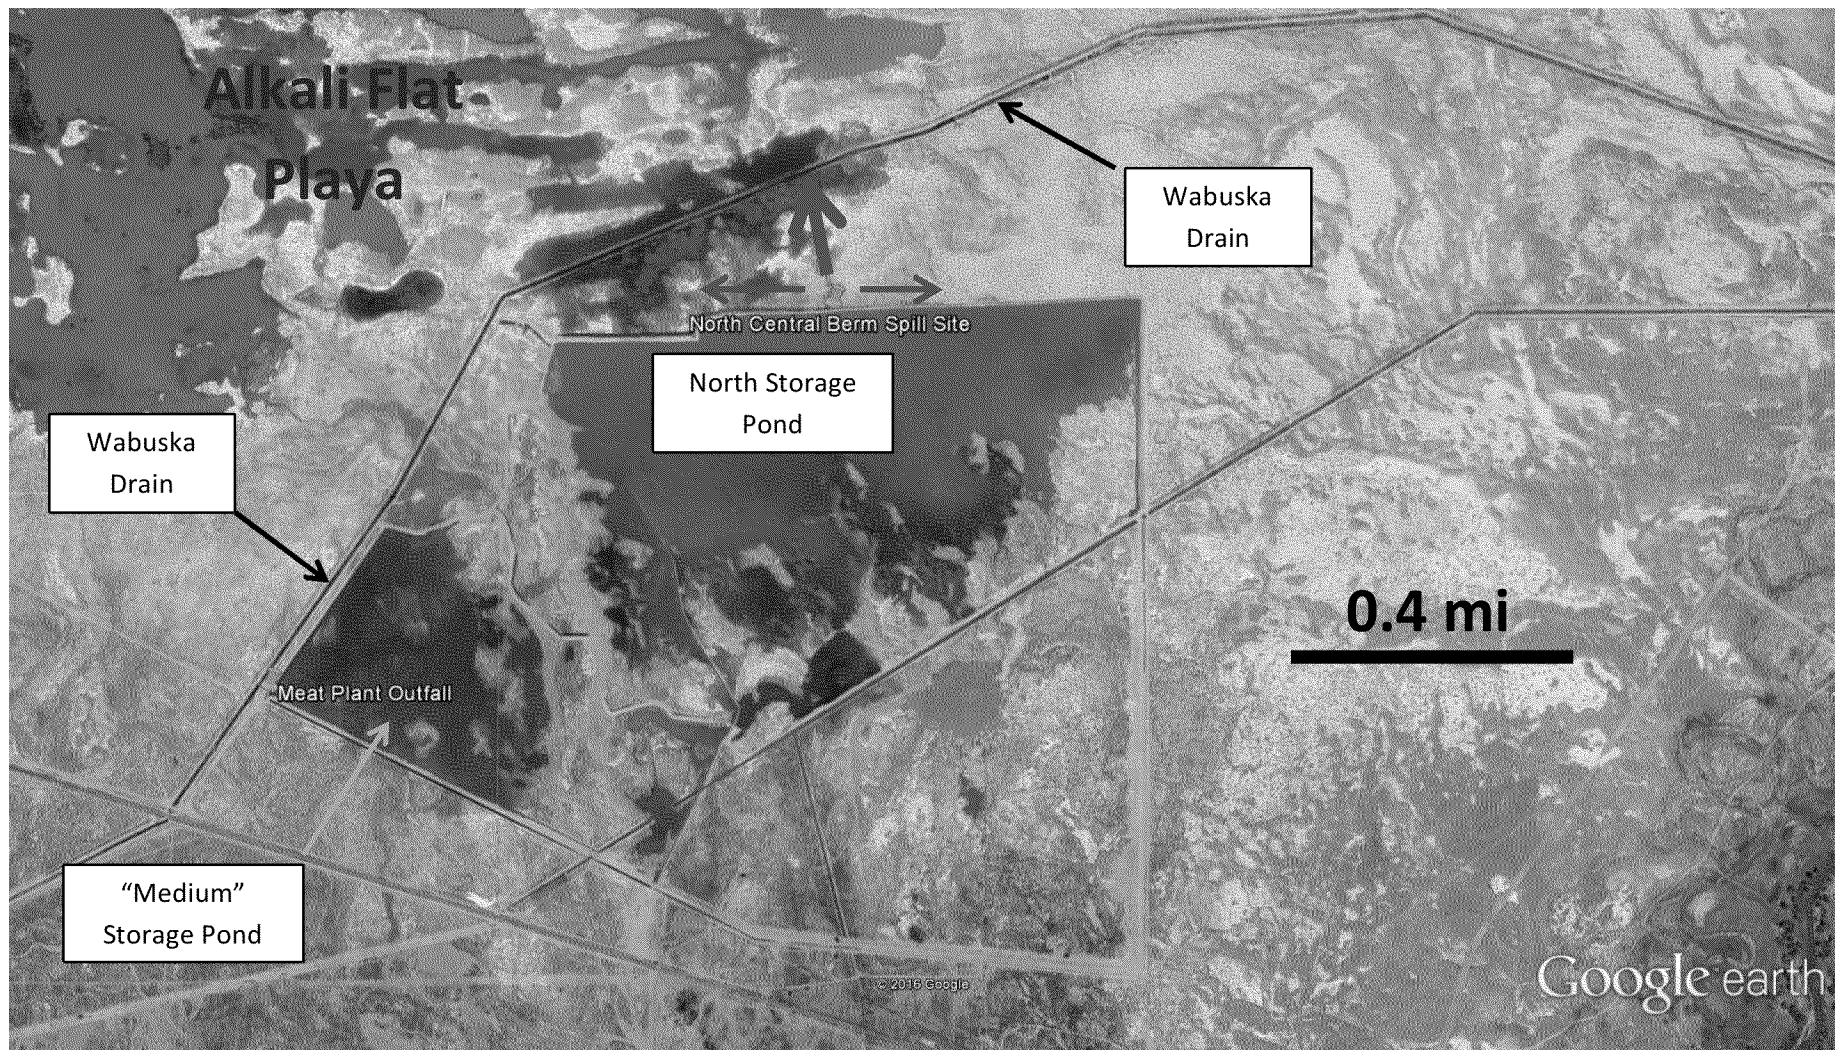
Figure 4: Detail map of Spill Report 160314-02 and area described in a 5-day report submitted by Homestretch Geothermal. The image shows that the North and Medium Storage Ponds have constructed barriers (berms) along some segments (constructed impoundments), ostensibly to prevent spillage into the Wabuska Drain. The path of flow from the spill is denoted by the thick red arrows (estimated by Homestretch). The northerly flow path is about 0.20 mile to the Wabuska Drain. Imagery date is 6/13/15.

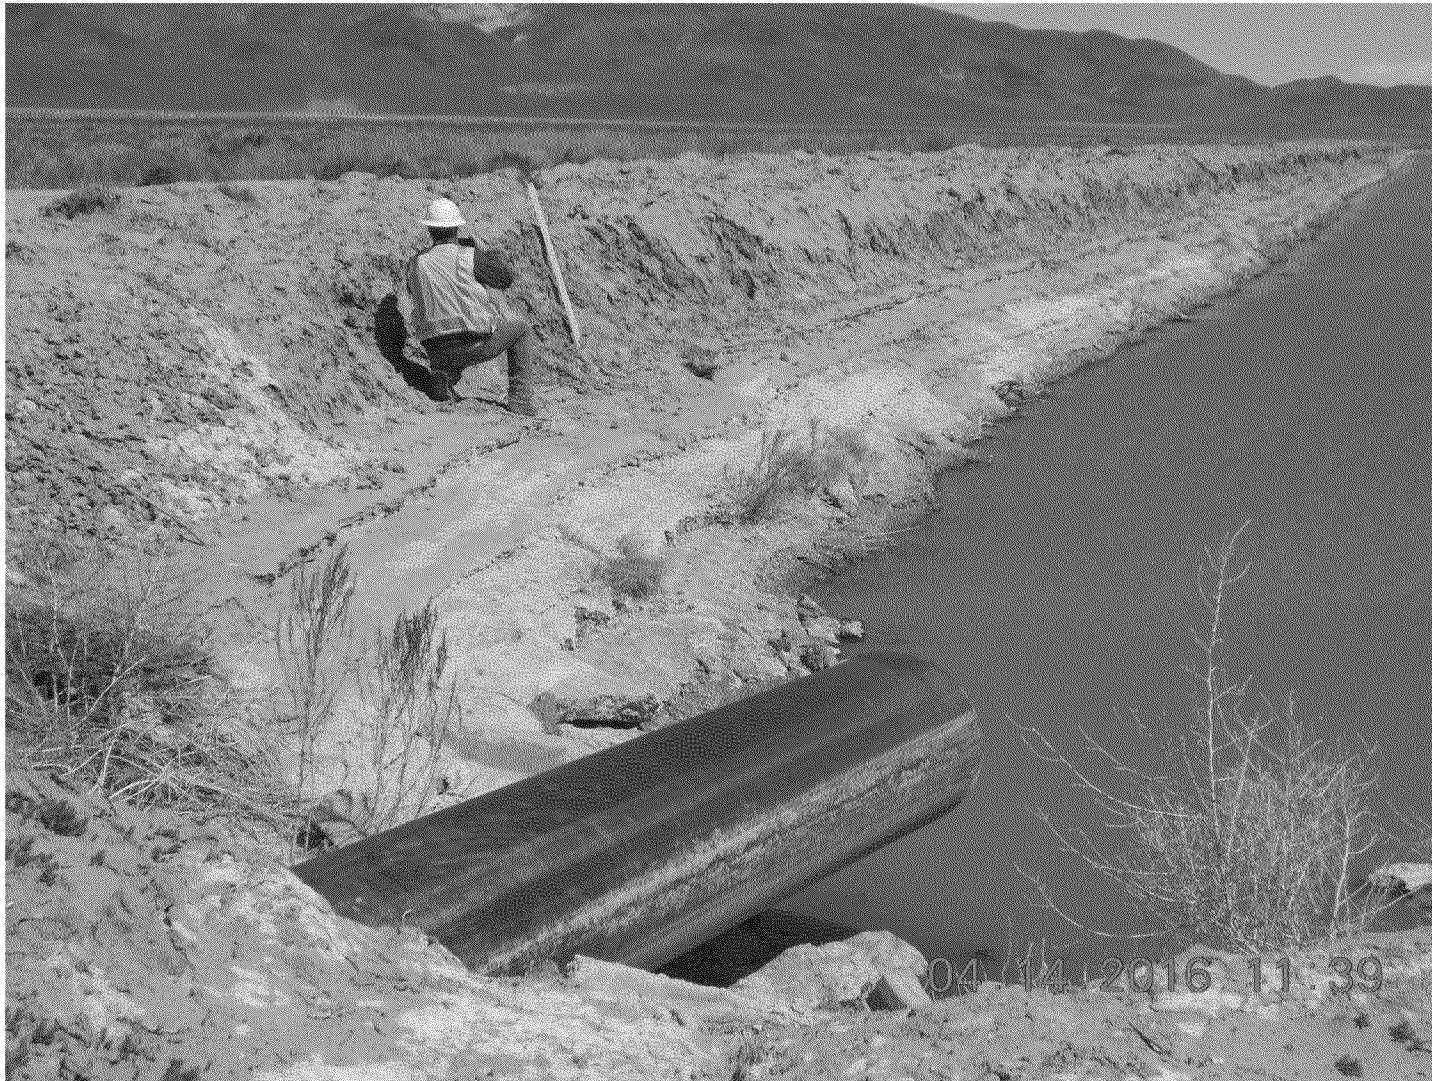
Photo 1: The Meat Plant Outfall pipe (Outfall 005 in NS0092037). Homestretch has not used the outfall since the January 22 spill. The constructed embankment being measured by the DWR water engineer trends NNE and is constructed parallel to the Wabuska Drain, ostensibly to prevent spillage into the drain. The Wabuska Drain is out of view, left of the embankment.

As noted in their "Five Day Report", Homestretch has not discharged geothermal water from the Meat Plant Outfall 005 since the January 22 spill. C. Egbert indicated that the area around the spill site is too wet to move equipment in to rehabilitate the North Central Berm. But, C. Egbert indicated that they would like to eventually restore and strengthen the berm once the area is dry enough.

| 3 | The BWPC must not approve any discharge of spent geothermal water to the Meat Plant Outfall (005) until such time as all NDWR and NDEP-BWPC compliance issues are resolved. |

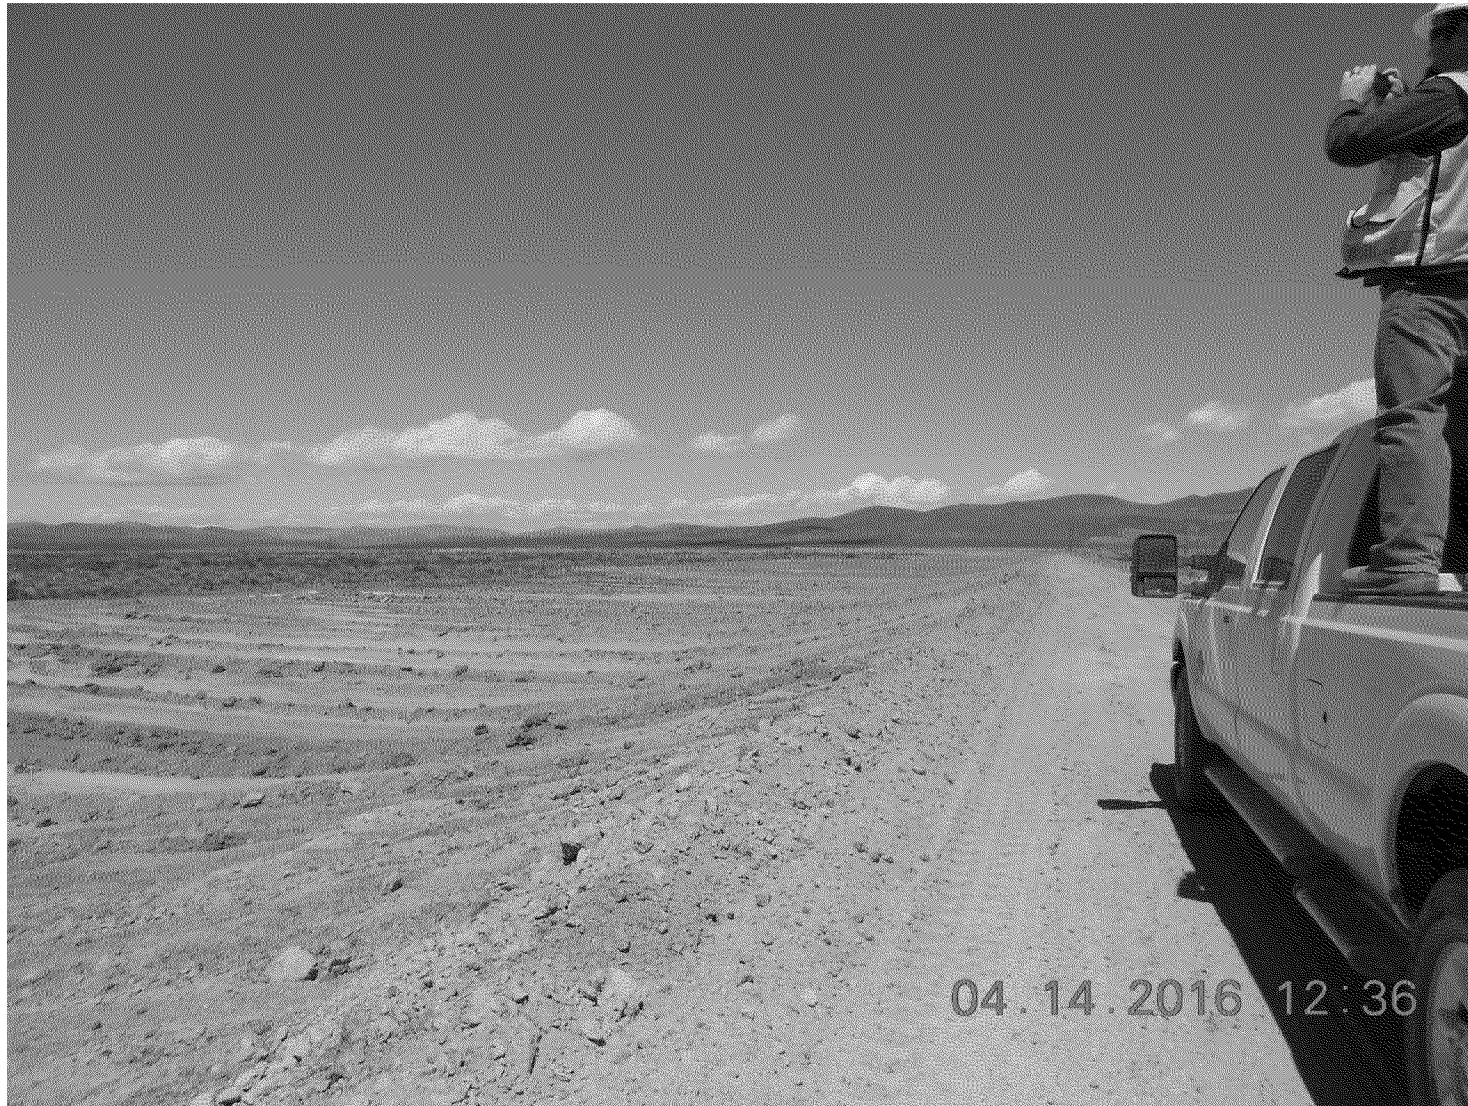
DCNR staff were also shown a newly-constructed, narrow impoundment structure for water storage in the western half of the Palmer Tract. The length of the impoundment is estimated to be about 1.4 miles, based on odometer readings while driving on the top of the constructed berm. The impoundment observed by DCNR staff is shallow (nominally 5 feet deep at the lowest point) and asymmetric. The

newly-constructed impoundment is nominally 100 feet wide.

Photo 2: The newly-constructed impoundment in the Palmer Tract area. The road trends approximately due North, and is on the top of a berm. On the left is a shallow, asymmetric impoundment, constructed by Homestretch presumably for water storage. Homestretch also intends to conduct irrigation on portions of the Palmer property.

| 4 | Prohibit Homestretch from discharging run-off irrigation water or other water to the newly-constructed storage impoundment on the Palmer Tract, until such time as the NDWR certifies and permits the new impoundment on the Palmer Tract. |

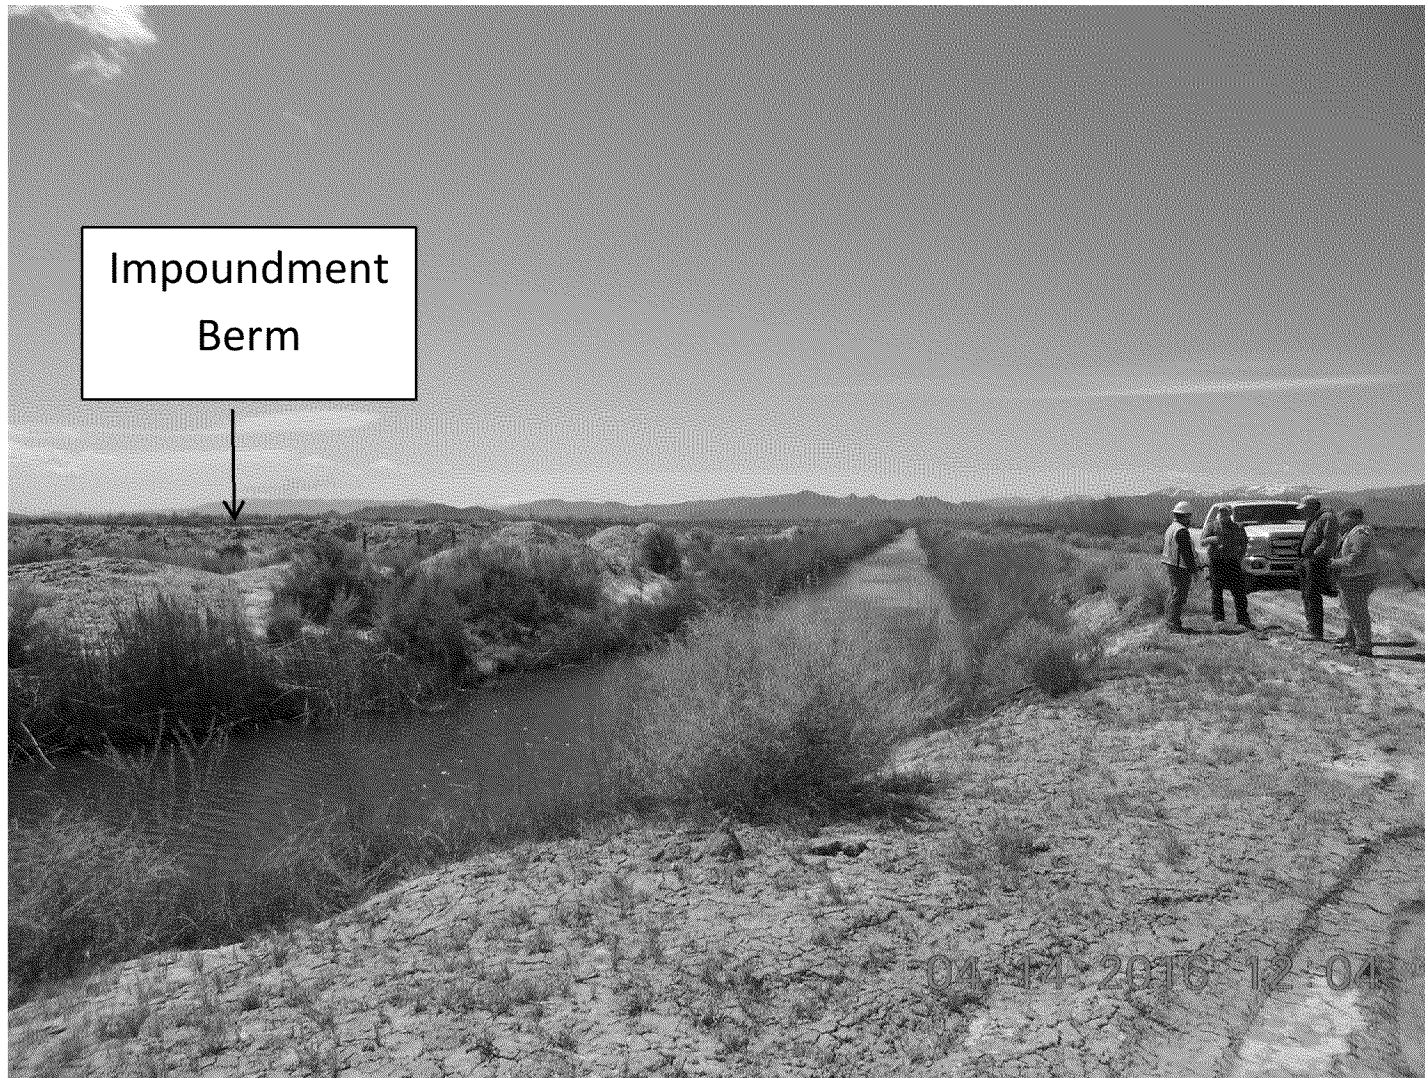
Photo 3: View of the Wabuska Drain looking southeast. This location is approximately 0.70 miles NE from the Meat Plant Outfall pipe. The west side of the “North Central Berm” is located left of the Drain near the fence posts.

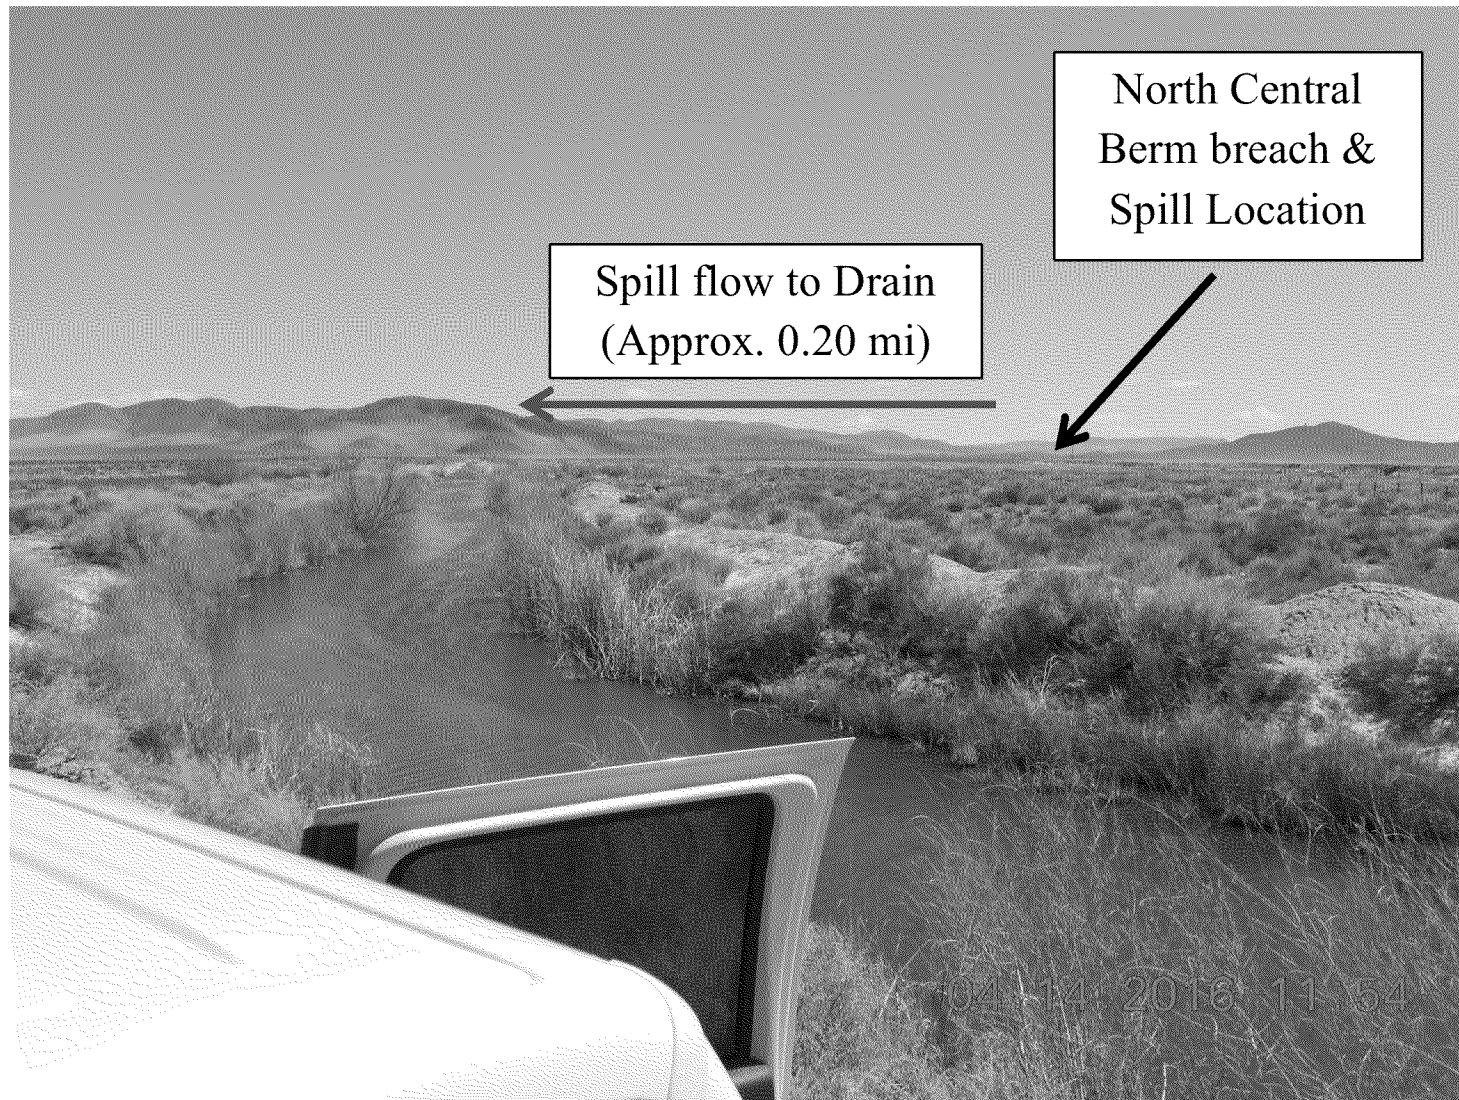
boundary of the Morose Tract on April 14, but were not able to go to the location of the spill site. The spill site was not accessible because of continued wet conditions on the ground. Homestretch pointed out the location of the breach, which was about 0.5 mile due east of the point of observation (see Photo 4).

As noted in Homestretch's "Five Day Report", discharge from the spill flowed in a northerly direction onto BLM land, into and over the Wabuska Drain, and then onto the southeastern part of the Alkali Flat Playa. Homestretch indicated that the width of the impoundment breach is about 50 feet.

Photo 4: View of the Wabuska Drain looking ENE. This location is approximately 0.70 miles NE from the Meat Plant Outfall pipe. The approximate location of the breach in the North Central Berm is shown by the arrow, as pointed out to NDEP staff by Homestretch, which is due east of the photographer, approximately 0.50 mile away. The location of the breach was not accessible.

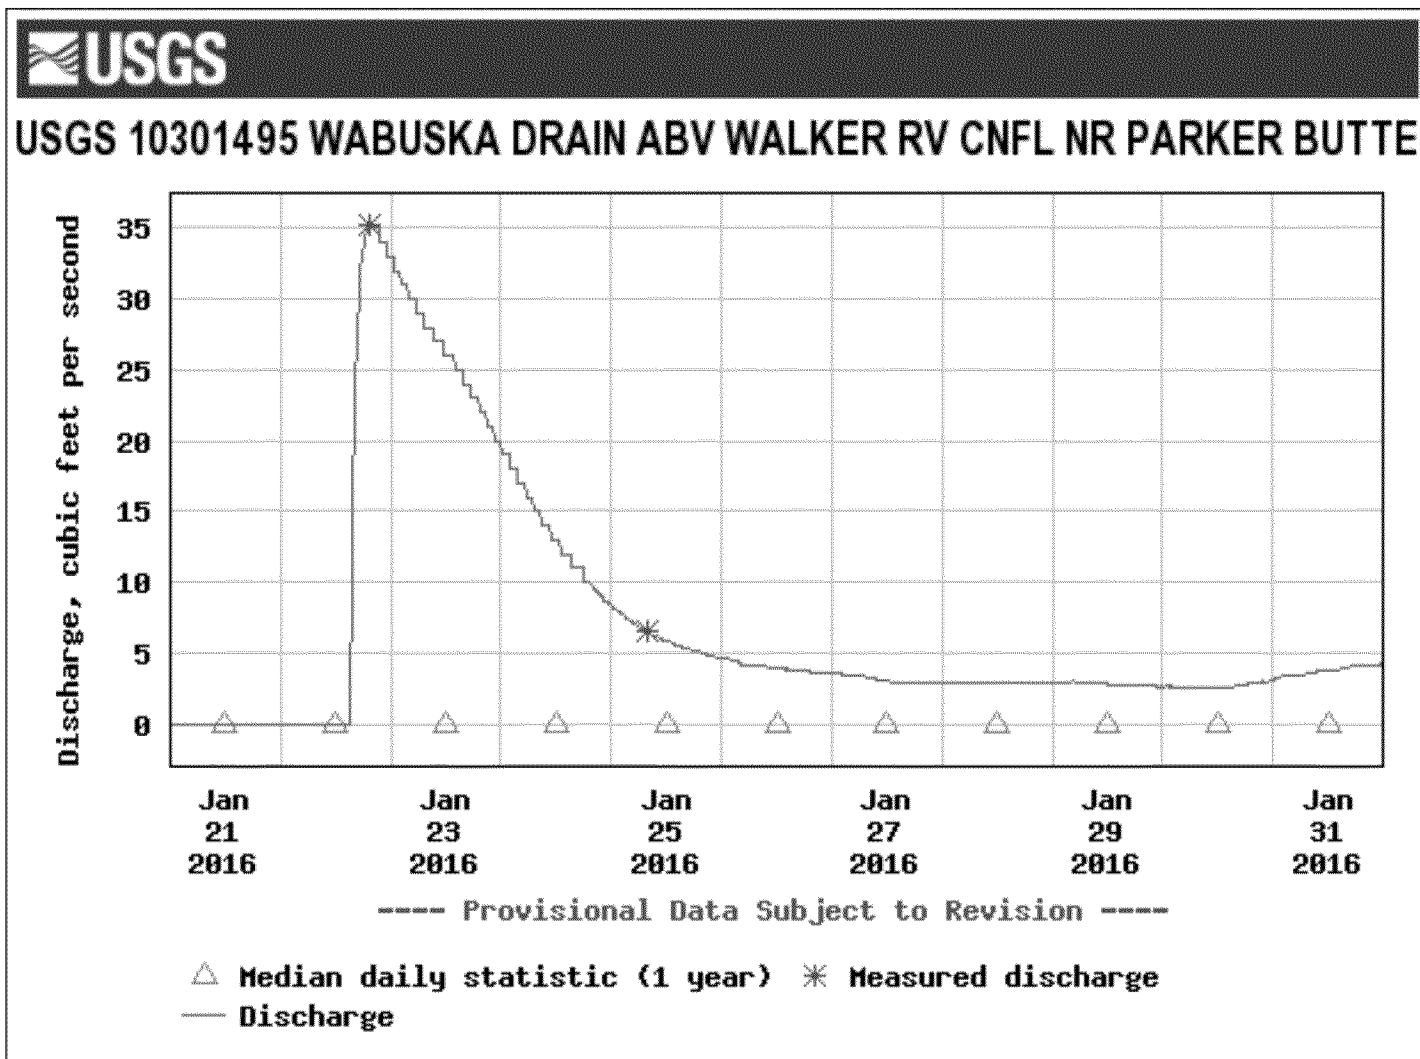
It appears from the USGS hydrograph that flow in the drain returned to a base level of 4 cfs after 4 to 5 days. The maximum flow observed at the gauging station from the spill was 35 cfs on January 22, 2016.

Figure 5: USGS Hydrograph 10301495 for the Wabuska Drain showing a spike in discharge coincident with the timeframe of the breach of Homestretch's North Central Berm on January 22 – 23, 2016. The location of the gauging station is noted in Figures 1 and 2.

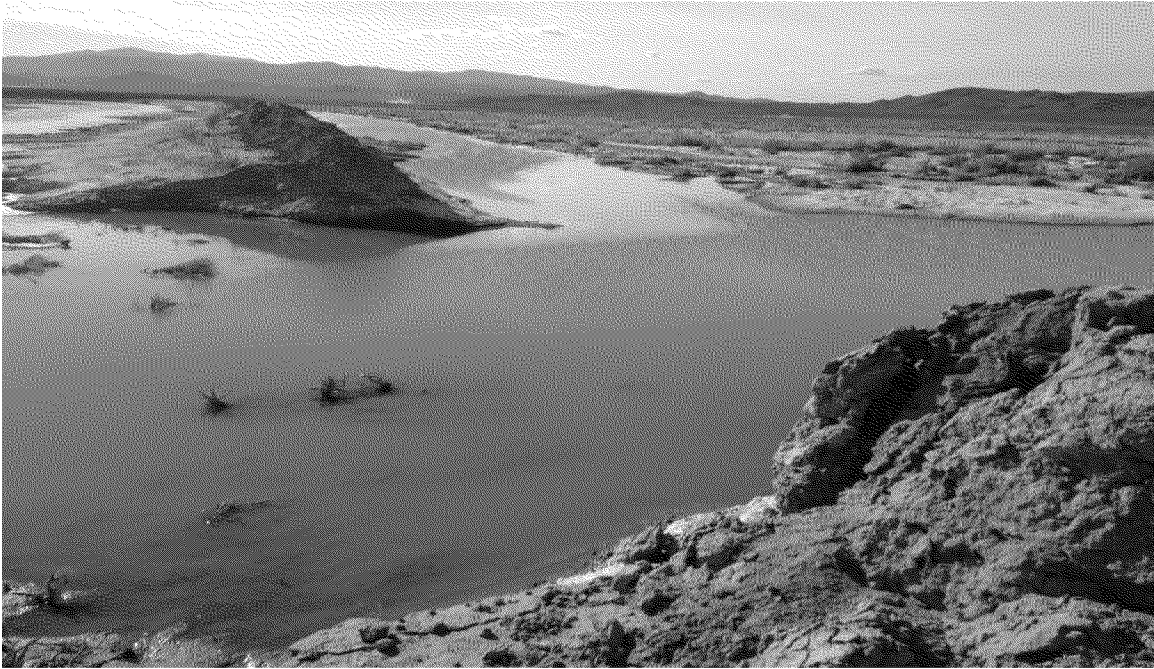
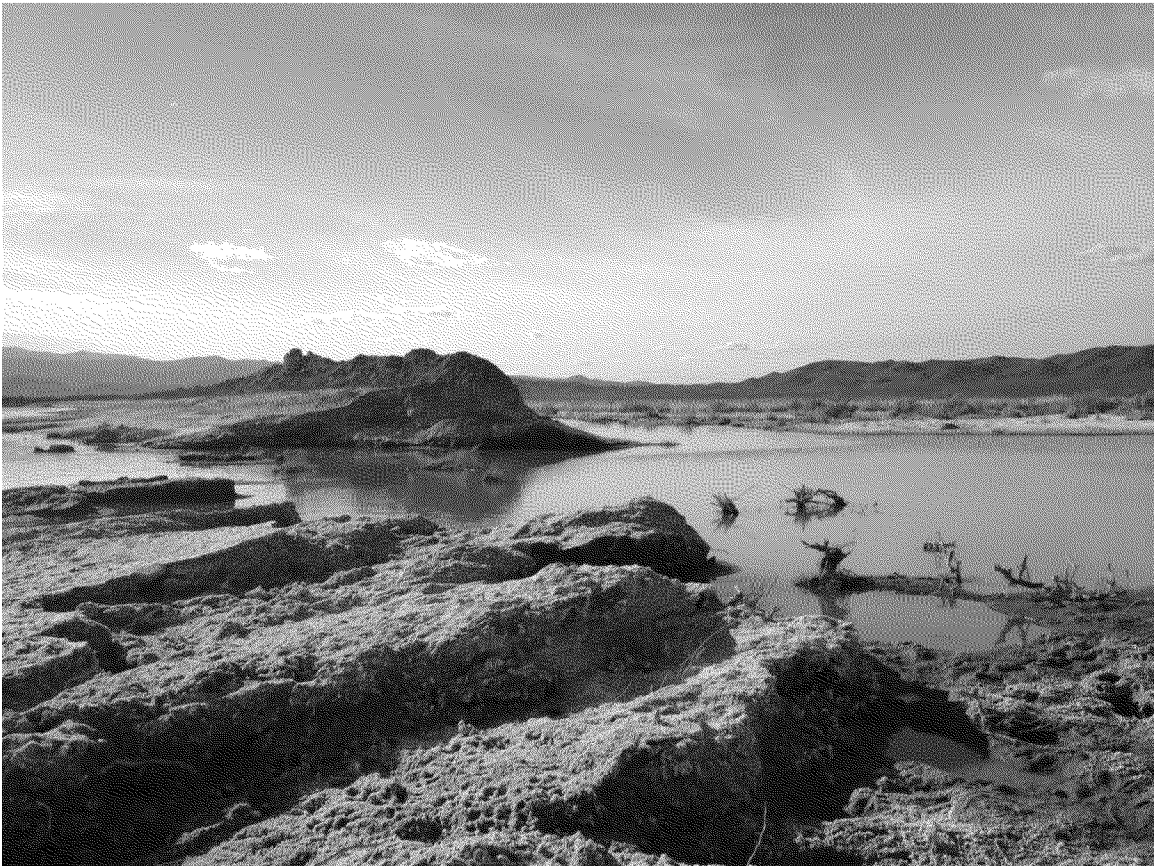
EXHIBIT “D” PHOTOS OF SPILL LOCATION

1. Berm failure due to extreme weather. In the days prior to the Spill, severe winter weather including wind, rain, and snowfall in the vicinity of the berm, may have degraded the berm at an accelerated rate, with precipitation causing the top of the berm to settle further, and high winds creating waves which further eroded the berm until it failed.

2. Berm failure due to degradation over time. It is possible that the failure of the berm was the result of multiple factors, such as settling, erosion, wave action, etc., which over time weakened the berm enough to allow the Spill to begin, and then quickly compromise a larger portion of the berm.

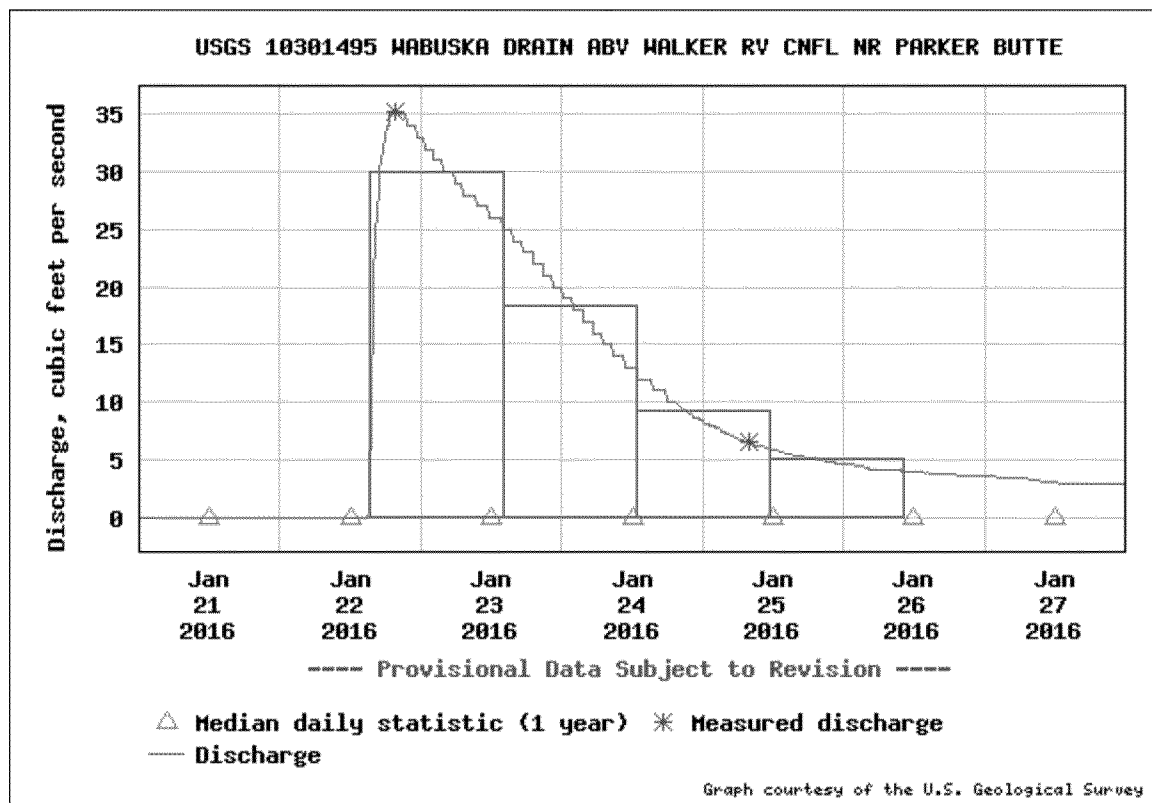
1 cfs = 1.984 Acre-feet for a 24 hour period

So the area under the curve was divided into 4 parts (each about 24 hrs) to approximate the flow from the breached impoundment to the Wabuska drain.

The daily flow rates of; 30 cfs + 18 cfs + 9 cfs + 5 cfs = 62 cfs cumulative over the 4 day period, total to about 123 acre-feet
